Determination 2012/057

Regarding the issuing of a code compliance certificate for a house with a log fire installed at 566 Tunakino Valley Road, Rai Valley, Marlborough

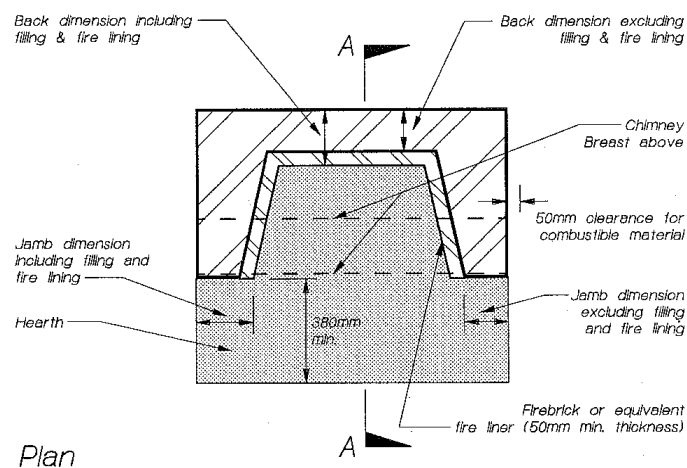
Figure 1: Chimney terms and dimensions

A2. Figure 1 from the Acceptable Solution current at the time the building consent was issued (C1/AS1, 1st edition: Amendment 2, effective from 28 February 1998).

Paragraph 1.1 and Table 1

- 7.2.8 I also note that a hearth defines an area where combustible material should not be placed. Combustible material may well be placed up against a hearth by an owner with the reasonable expectation that it will be safe. Figure 1 of C1/AS1 shows a hearth projecting 380mm from an open fireplace; and the owners may well wish to take this more conservative approach by removing the timber trim and lino to this distance from the grate.
